Part 2 – Recommended Treatment and Use

2.A Conditions Assessment and Recommendations

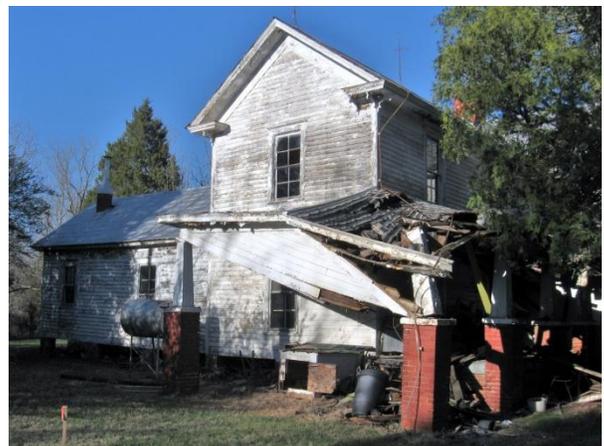
The front porch roof has all but completely collapsed, and will require complete removal pending replacement.³³ Detailed documentation of the existing porch will be necessary to replicate the feature, but should be done regardless for archival purposes.

Figure 50 - Long House. Southwest oblique showing structural collapse of roof at porch and porte cochere as of April 2013. Compare with conditions one year earlier in Figure 14.

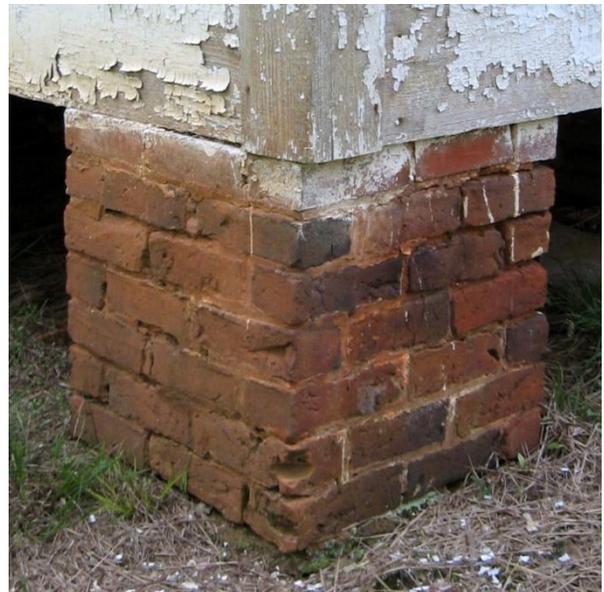
With some exception, the brick foundation piers are generally in fair condition. Mortar is typically weathered, and some bricks are displaced. At least one of the piers has settled out of plumb. The piers are unreinforced, and the sill bears upon the pier without any substantial connection.

Figure 51 - Long House. Brick pier at northeast corner of east wing. Note erosion in mortar joints.

All mortar joints should be repointed with a low-compressive strength lime mortar to match the color of the existing. In addition to repair of the existing brick piers, the installation of supplemental piers in the crawl space may be required.

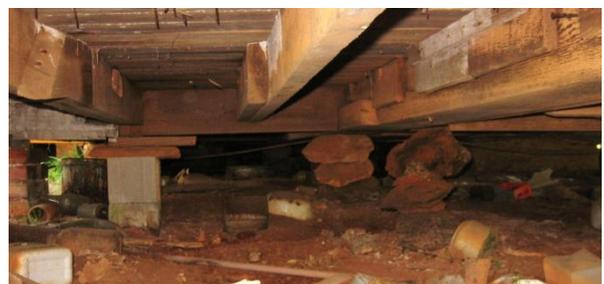
Figure 52 - Long House. Typical dry-stacked piers in crawl space under east wing.

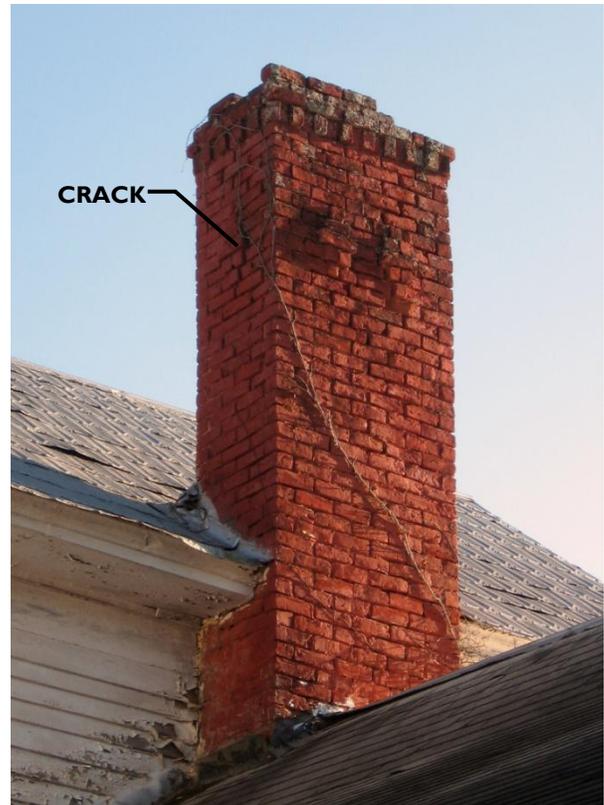
Due to extreme exposure over the years, the brick chimneys are generally in poor condition. Although they are standing plumb, the substantial erosion of mortar joints throughout the stacks implies that the bricks are effectively dry-stacked and without bonding structure.

Figure 53 - Long House. Chimney at north wall of west wing. Note crack in east face and severe erosion of mortar joints. Deterioration of masonry and flashing has caused damage to wall framing, ceiling and wall paneling at SW Bedroom 202.

All bricks should be set in and/or mortar joints repointed with a low-compressive strength lime mortar to match the color of the existing. During repair of the chimneys, the installation

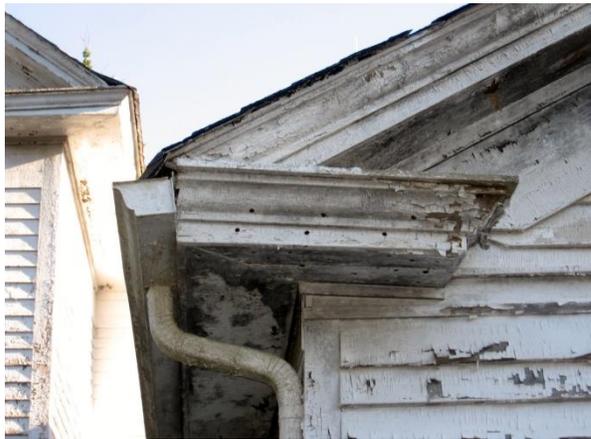
Overall, not including the front porch, the wood siding and trim are in good condition underneath thick, cracked layers of paint. Areas that have experienced the most damage include the soffit and cornice, owing to extreme exposure. Siding intersecting the roof of the one-story kitchen wing also shows some deterioration at the roof line.

Figure 54 – Soffit detail at northeast corner of Kitchen wing, showing typical condition of paint on siding and trim.

properties. All dimensions and detailing should match the feature to be replaced. Damaged wood which is judged suitable for restoration should be repaired using traditional dutchman infill and/or epoxy consolidation and infill as applicable.

Once repaired, the substrate will require extensive preparation for a long-term paint finish. Existing paint coatings should be completely removed down to bare wood using a combination of scraping, infrared heat, and chemical stripping as applicable.

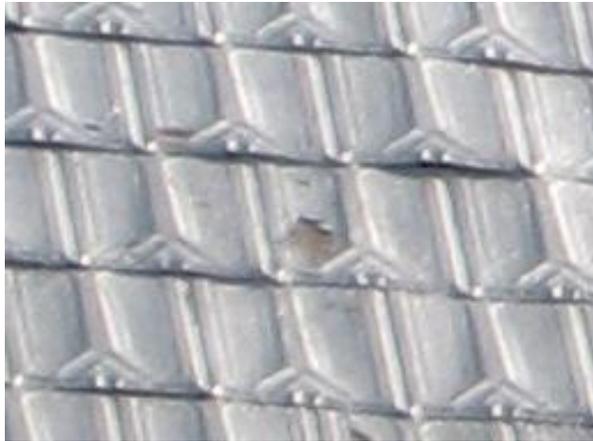
The stamped galvanized steel shingles on the main roof appear to be in good condition overall. The aluminized coating is built up in thickness and is failing in places, although significant rusting was not observed in the shingles or ridge caps. The galvanized flashing at the chimneys appears to have failed.

Figure 55 – Detail of stamped metal shingles. Note limited failure of coating on shingle at center of photo.

Assuming an interpretive period for the house extending through the mid-1940s – the latest period of significance – the existing stamped metal shingle roof should be preserved and restored. The east face of the Kitchen wing roof would require replacement with metal shingles to match the size, detailing and pattern of the existing shingles.

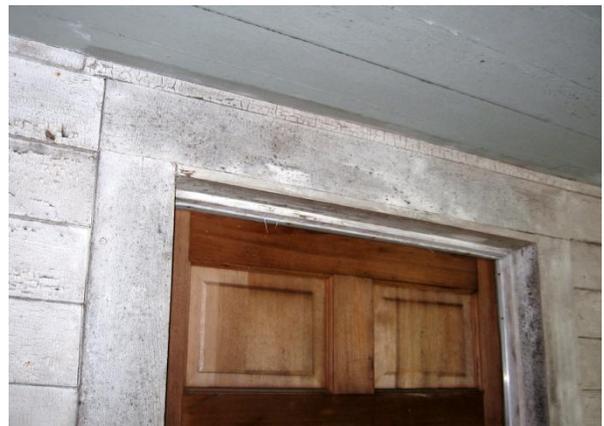
The doors leading from the Back Porch to the Kitchen (103) and Dining Room (103) have been replaced with modern six-panel doors. To accommodate the replacements, the door frame and casing were reworked and the molded caps were chiseled off.

Figure 57 – Doorway leading from Back Porch to Dining Room. Door and casing are modern replacements, and molded cap has been chiseled back flush with the casing.

The modern replacement doors to the Kitchen (102) and Dining Room (103) should be replaced with replica four-panel doors to match the back door to the Stair Hall (101). The altered door frame and casing should be replaced to match the detailing of the back Stair Hall door, including reconstruction of the molded caps over the door head.

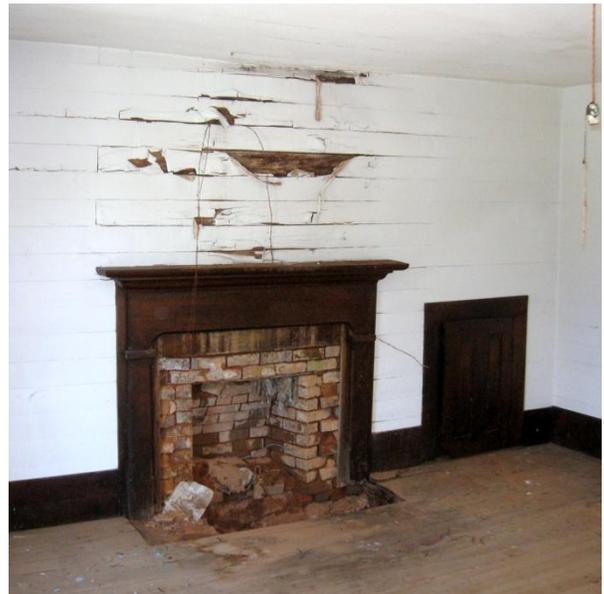
Overall, the wall and ceiling sheathing throughout the house is in good condition. Deterioration of the painted finish on the ceilings, walls and trim is the main concern. The exception is in Room 202 where leaks around the chimney have damaged wall sheathing beyond repair, and in Room 102 below where a section of ceiling sheathing has collapsed under the hearth.

Figure 58 – North wall of SW Bedroom 202 showing severe water damage to wall sheathing – and possibly framing – at the chimney.

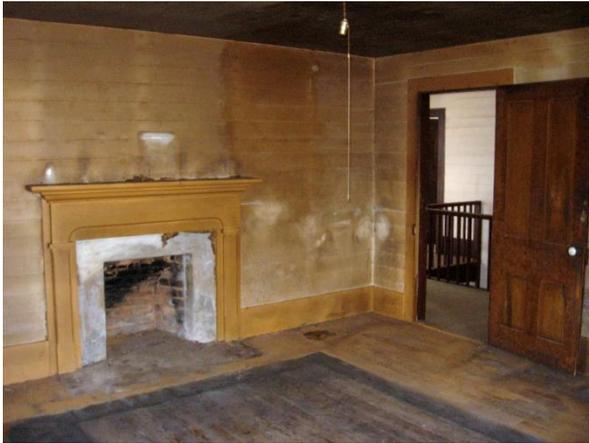
Wood flooring is in fair condition throughout,

with the finish typically worn through. Some areas of flooring have been painted.

Figure 59 – NE Bedroom 203 showing a painted border on the flooring, delineating where a linoleum rug had been.

Given cupping of the floorboards in places, the use of drum sanders must be avoided to avoid damage. Selective use of belt and orbital sanders may be necessary.

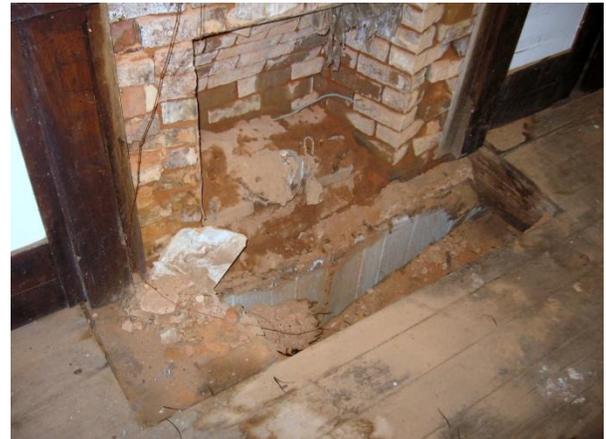
Deterioration of the chimneys has dumped sand and brick dust on the firebox throats. In the SW Bedroom (202), leaking from the deteriorated chimney has caused the brick hearth to collapse through the ceiling below.

Figure 61 – Collapsed hearth in SW Bedroom 202 caused by failure of wood forms and framing due to leaks from chimney.

In the Southwest Bedroom (202), the collapsed hearth should be restored, together with related repairs to damaged wood framing.

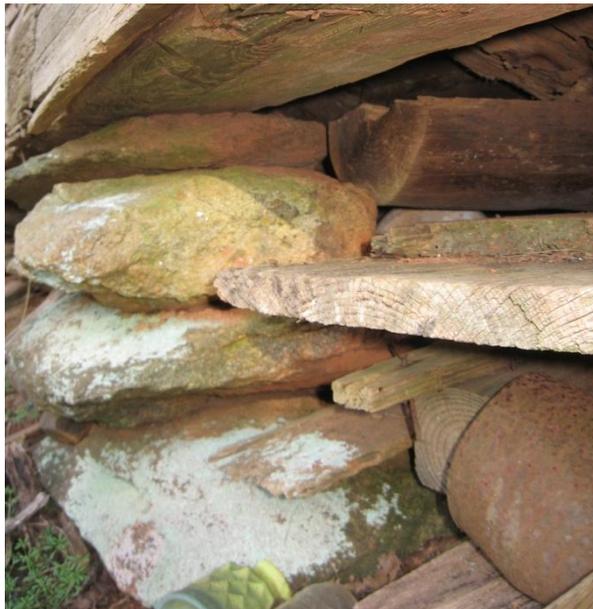
At least eight dry-stacked fieldstone piers support the 8-inch square hewn sills. As there is no mortar holding the stones together, only the weight of the structure keeps the stones in place. The piers appear to be stable, although there is no positive connection between them and the sill.

Figure 62 – Tenant Cabin. Dry-stacked fieldstone pier.

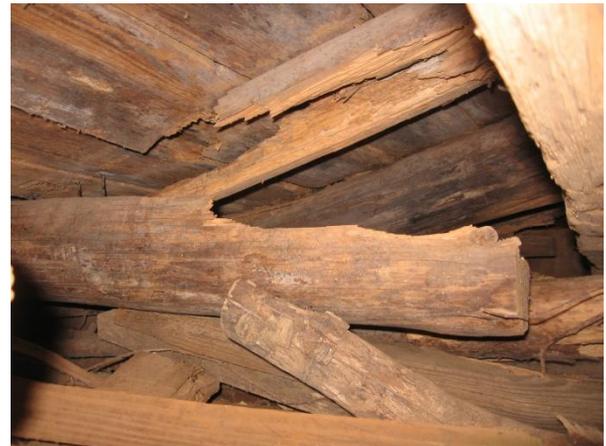
The un-hewn log floor joists have collapsed on the north side of the cabin due to overloading of the floor. The top sections of the logs that bear on the hewn sill have split away from the bottom of the joist, causing the joists to collapse along that wall. The condition of the joists at the south wall could not be determined; however, given the low clearance to grade there, it is assumed that the joist ends are deteriorated due to decay and/or insect damage.

Figure 63 – Tenant Cabin. Log joist split in half at the sill (at right). The joist beyond appears to have failed mid-span.

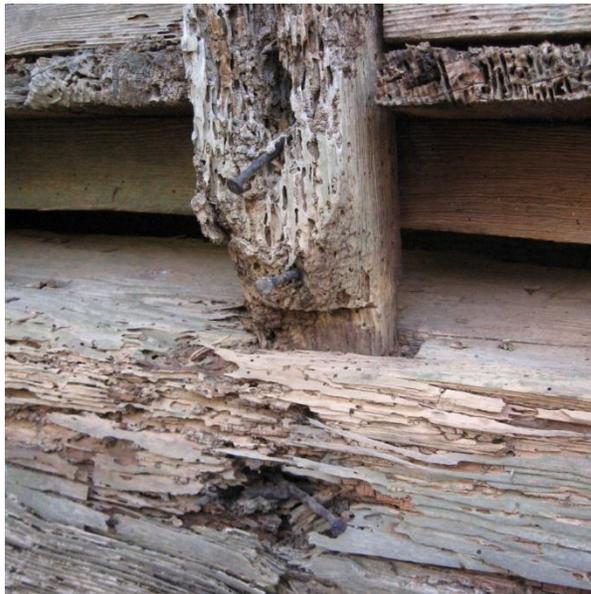
Where long exposed to weather on the east side, the 3x4-inch sawn studs show signs of decay at the bottom ends. Where protected, the wall studs appear to be in good condition, such as viewed from the porch attic.

Figure 64 – Tenant Cabin. Wall stud mortised into sill at east wall. Note insect damage at edge of flooring.

The east wall, long exposed to weather, may require substantial reconstruction. Deteriorated

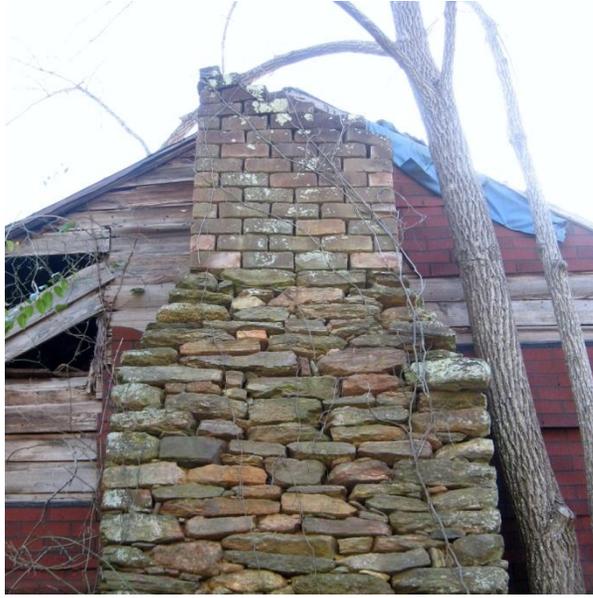
Figure 65 – Tenant Cabin. Stone chimney with brick flue.

Bricks that have fallen from the chimney must be gathered, brushed clean, then stacked and covered on a pallet off the ground. The chimney flue stack should be reconstructed using the salvaged brick, with reproduction brick worked in as necessary. The chimney should have a coping of stainless steel, detailed in such a fashion that the coping is not visible.

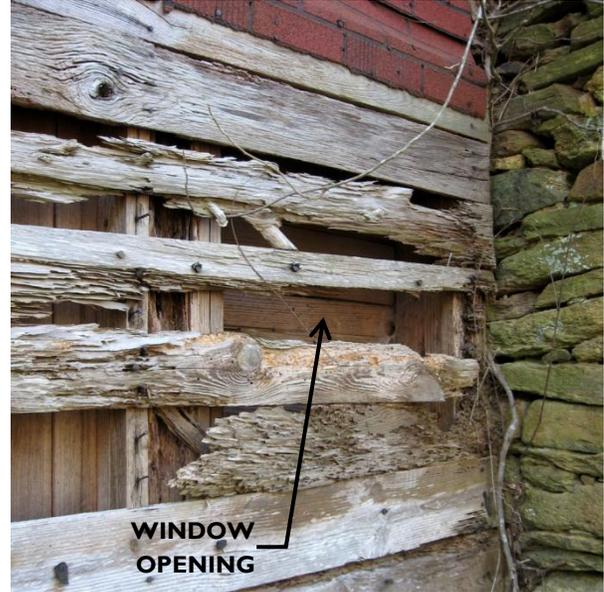
the asphalt siding is deteriorated throughout, and very likely contains asbestos. Other siding materials such as metal roofing have been haphazardly installed.

Figure 66 – Tenant House. Detail of rough sheathing at east wall. Note sheathing covers original window opening.

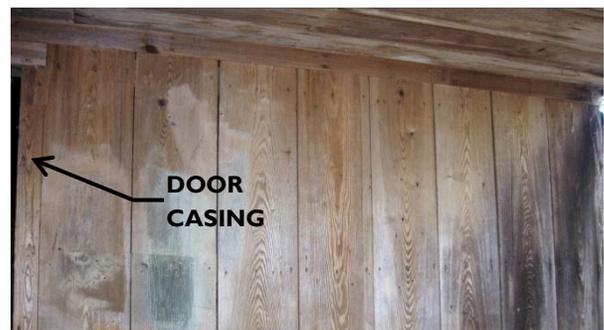
The vertical board sheathing on the porch wall does not have battens; the boards are butted tightly together. Over the years, shrinkage of the wood has allowed weather and insects into the wall cavity.

Figure 67 – Tenant House. Vertical board siding on porch. Note flush door casing at left, which is similar in size to the surviving casing on the window.

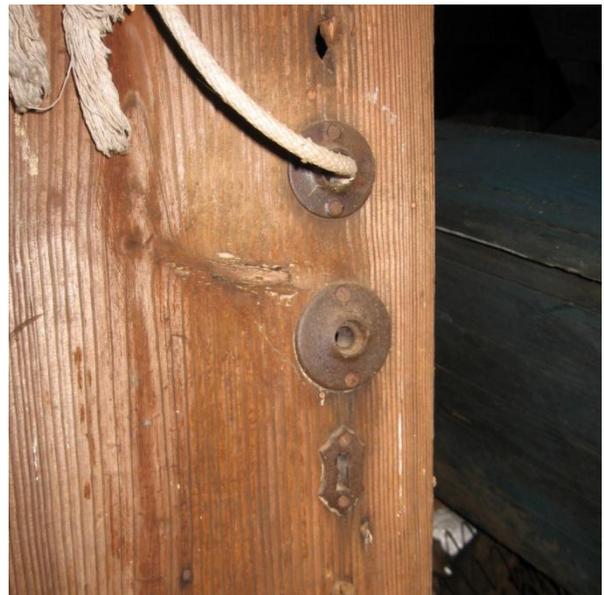
The board-and-batten door leading from the porch into the large hall is in good condition. The similar door on the north side shows significant weathering on its exterior face, and the bottom ends of the boards are decayed. The Door leading from the porch into the south room is split at the hinge side. Hardware is missing from all of the doors; however, stamped steel rosettes and escutcheons survive, along with ghost marks of other hardware.

Figure 68 – Tenant Cabin. Detail of front door showing late-1800s stamped steel rosette and escutcheon. The rim lock is missing.

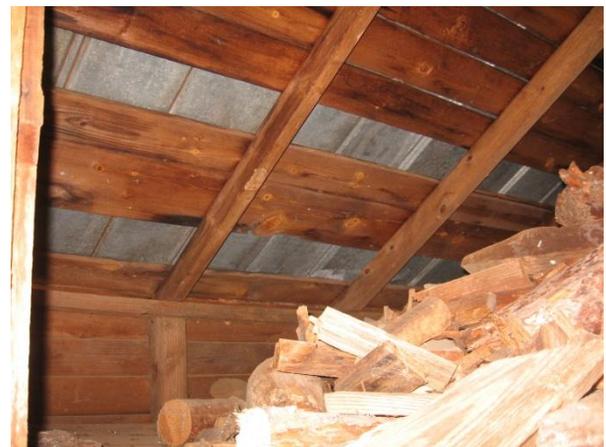
Figure 70 – Large Outbuilding. Attic loaded with firewood.

To avoid further damage to the floor framing, all firewood and other stored material should be removed from the building as soon as possible. Damaged first floor joists should be replaced with pressure treated material. Attic floor joists should be replaced to match dimensions and saw marks of the existing.
