Part 2 – Recommended Treatment and Use

2.A Conditions Assessment and Recommendations

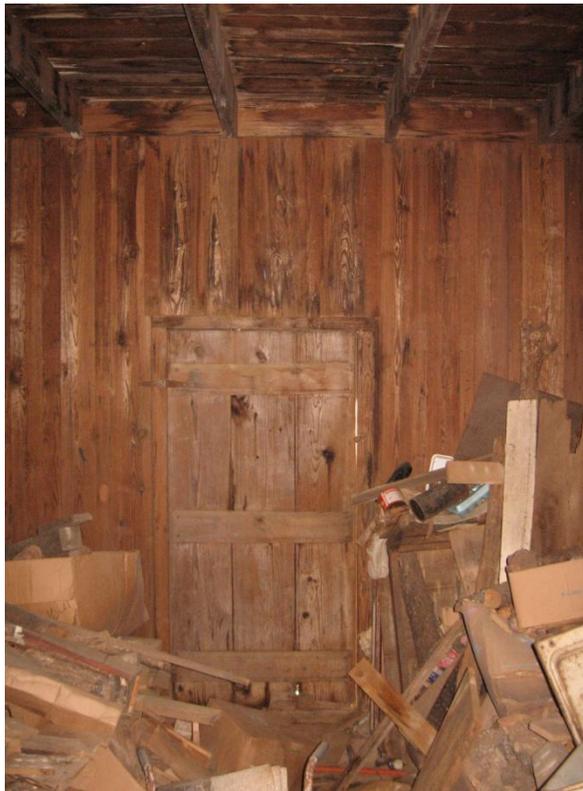
Figure 40 – Tenant Cabin. Interior of hall, view to north.

What could be observed of the yellow pine board-and-batten wall paneling appears to be in good condition. The wood appears to have never been finished. The attic flooring is made of square-edged boards, and has many gaps open to the attic (Figure 40).

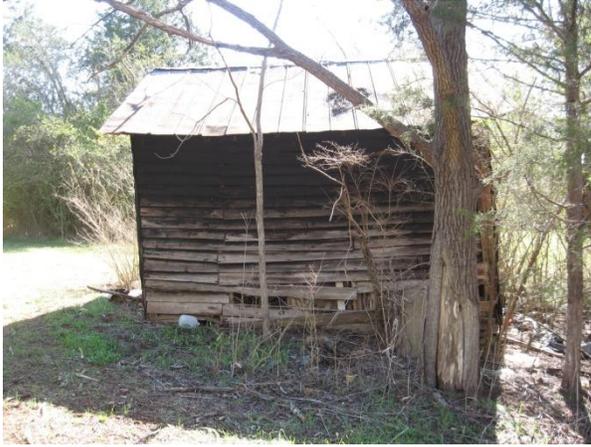
Figure 42 – Large Outbuilding. East elevation.

The frame building is supported on cinder block piers at the corners and mid-span of the sills. The front, or south, end of the building is at grade, and this end appears to have settled to the point where the building tilts to the south. See Figure 42.

Only the siding on the east wall remains exposed (Figure 42). Here, the siding is extremely weathered, but usable. The other

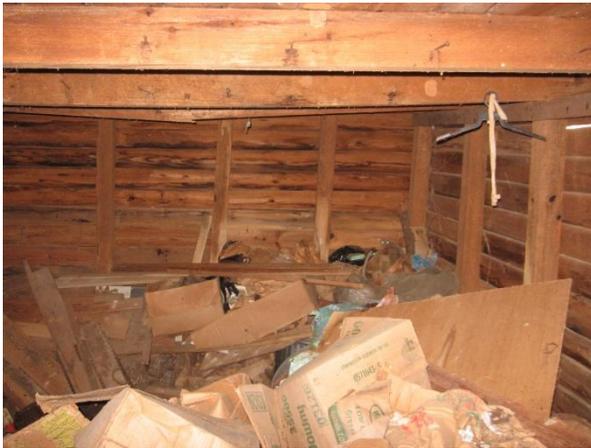
Figure 43 – Large Outbuilding. View of interior.

load imposed by the firewood storage, it is assumed that the joists are permanently deflected, where not completely failed. At least two attic joists were observed to have split at mid-span. See Figure 43. The sills along the east, south and west sides are assumed to have permanent deflection and possibly decay.

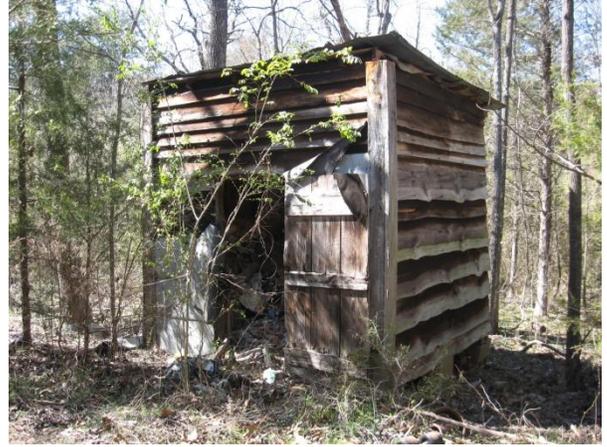
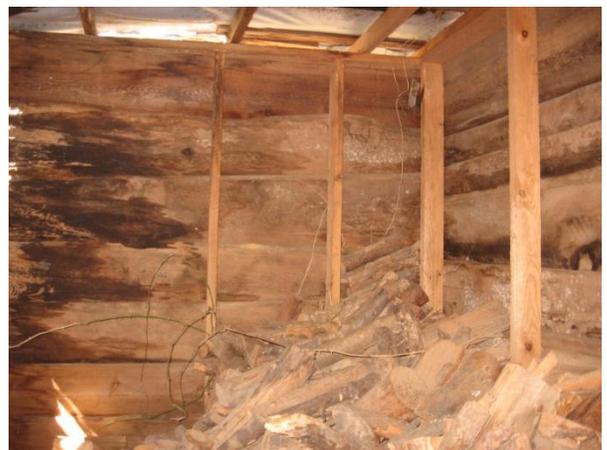
Figure 44 – Small Outbuilding. Southeast oblique.

Figure 45 – Small Outbuilding. View of interior.

Because the building is presently filled with firewood, an in-depth assessment could not be accomplished. Since no other evidence of an outhouse or bathhouse has been noted, it is conceivable that this building could have functioned as such. Once the interior is emptied, the building should be more closely examined. Refer to Figure 44 and Figure 45.

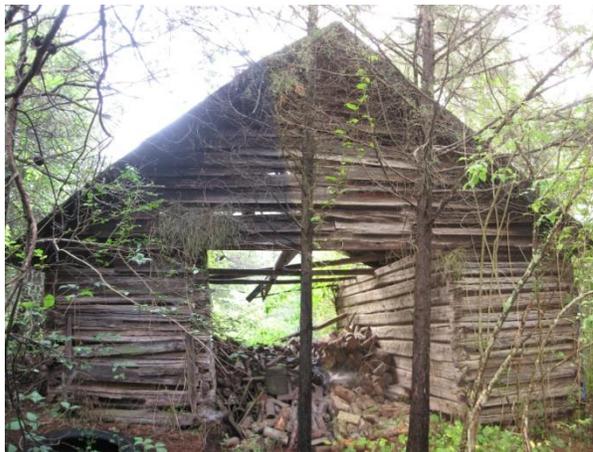
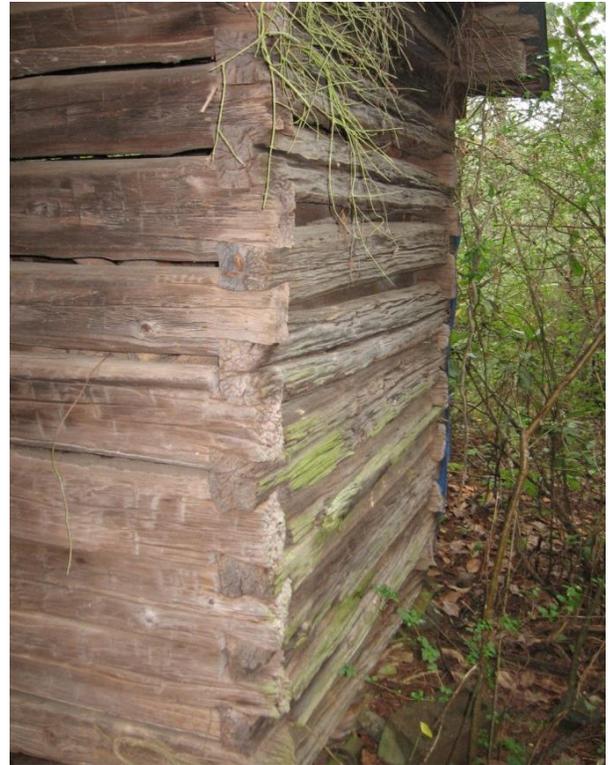
Figure 46 – Log Crib. West elevation (composite).

Figure 47 – Log Crib. Corner at southwest wall.

This building is not on the property; however, given the historical importance of the log crib, recommendations are made with regards to its stabilization as permitted by the owner. Refer to Figure 46 and Figure 47.

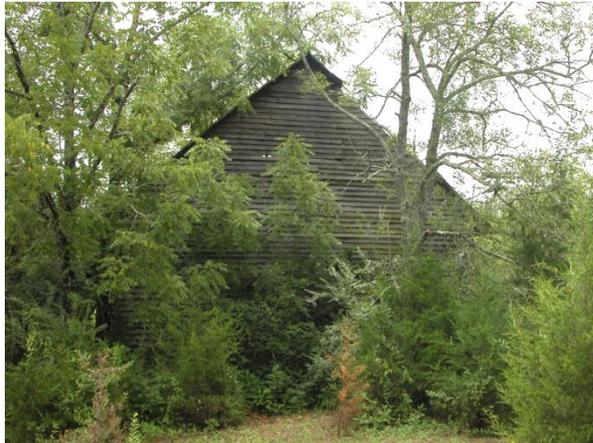
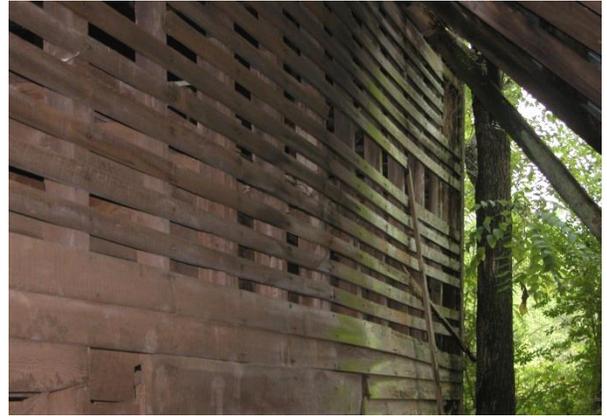
Figure 48 – Barn. North elevation.

Figure 49 – Barn. View of exterior wall under shed roof.

This building is not on the property; however, given the historical importance of the barn, recommendations are made with regards to its stabilization as permitted by the owner. The building could not be completely accessed, and a condition assessment was not conducted. Surrounding overgrowth constantly threatens the structure. Refer to Figure 48, Figure 49.

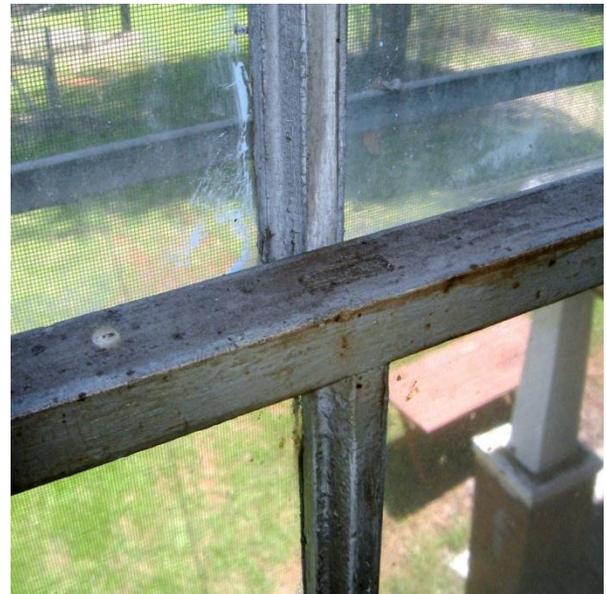
Figure 56 – Interior detail of window sash. Note thru-mortise connection at muntin to parting rail.

The original double-hung sash are in good condition overall, except for the glazing putty. In the NE Bedroom (105), the lower sash of the east window is missing its muntin bars. The lower sash in the south window, SW Parlor (102) is installed upside down. In the SE Bedroom (204), the top sash in the east window is installed upside down.
